ANNUAL REPORT FOR 2015

Bald Creek Site #1 Mitigation Site Yancey County TIP No. R-2518B

COE Action ID: SAW-2007-2197-357/300

Prepared By:
Natural Environment Section & Roadside Environmental Unit
North Carolina Department of Transportation
November 2015

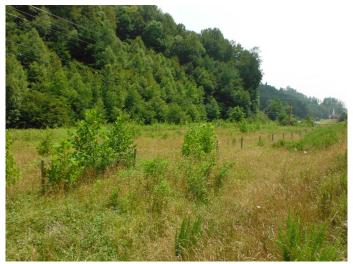
Vegetation Overview Photo

Streambank & Buffer Vegetation: The streambank reforestation was completed in March 2012. The Year 4 vegetation monitoring evaluation noted: Type II: Sycamore, Green Ash, Tulip Poplar and White Oak were surviving at the time of the monitoring evaluation.
